CASE STUDY PRESENTATION ON PIPER ALPHA AND SAN JUANICO INCIDENT

Conference on Chemical (Industrial) Disaster Management (CIDM)

C. Abhiram , GM (HSE), IOCL
July 1 2014

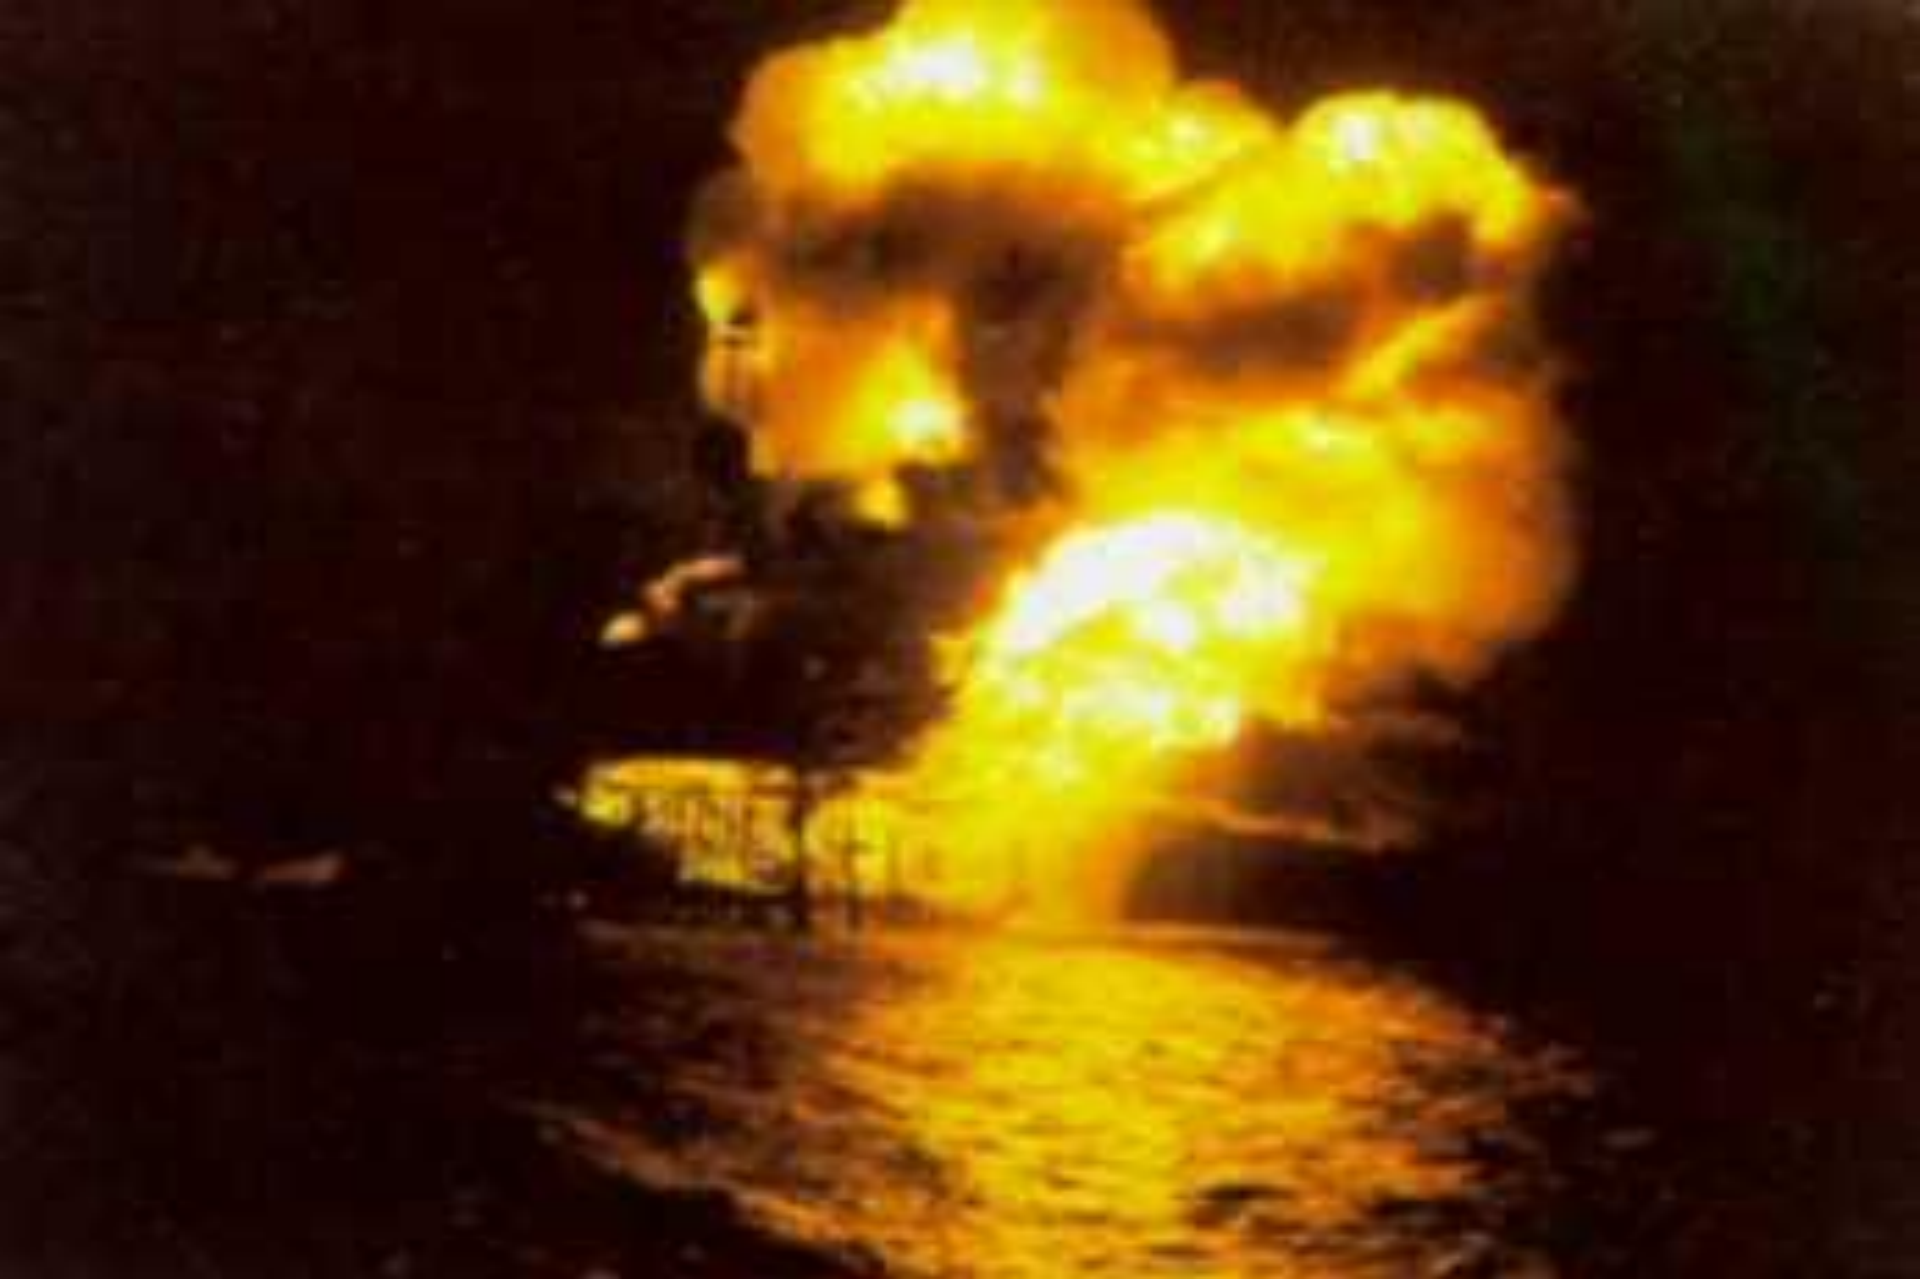
Fire on the Platform after riser rupture

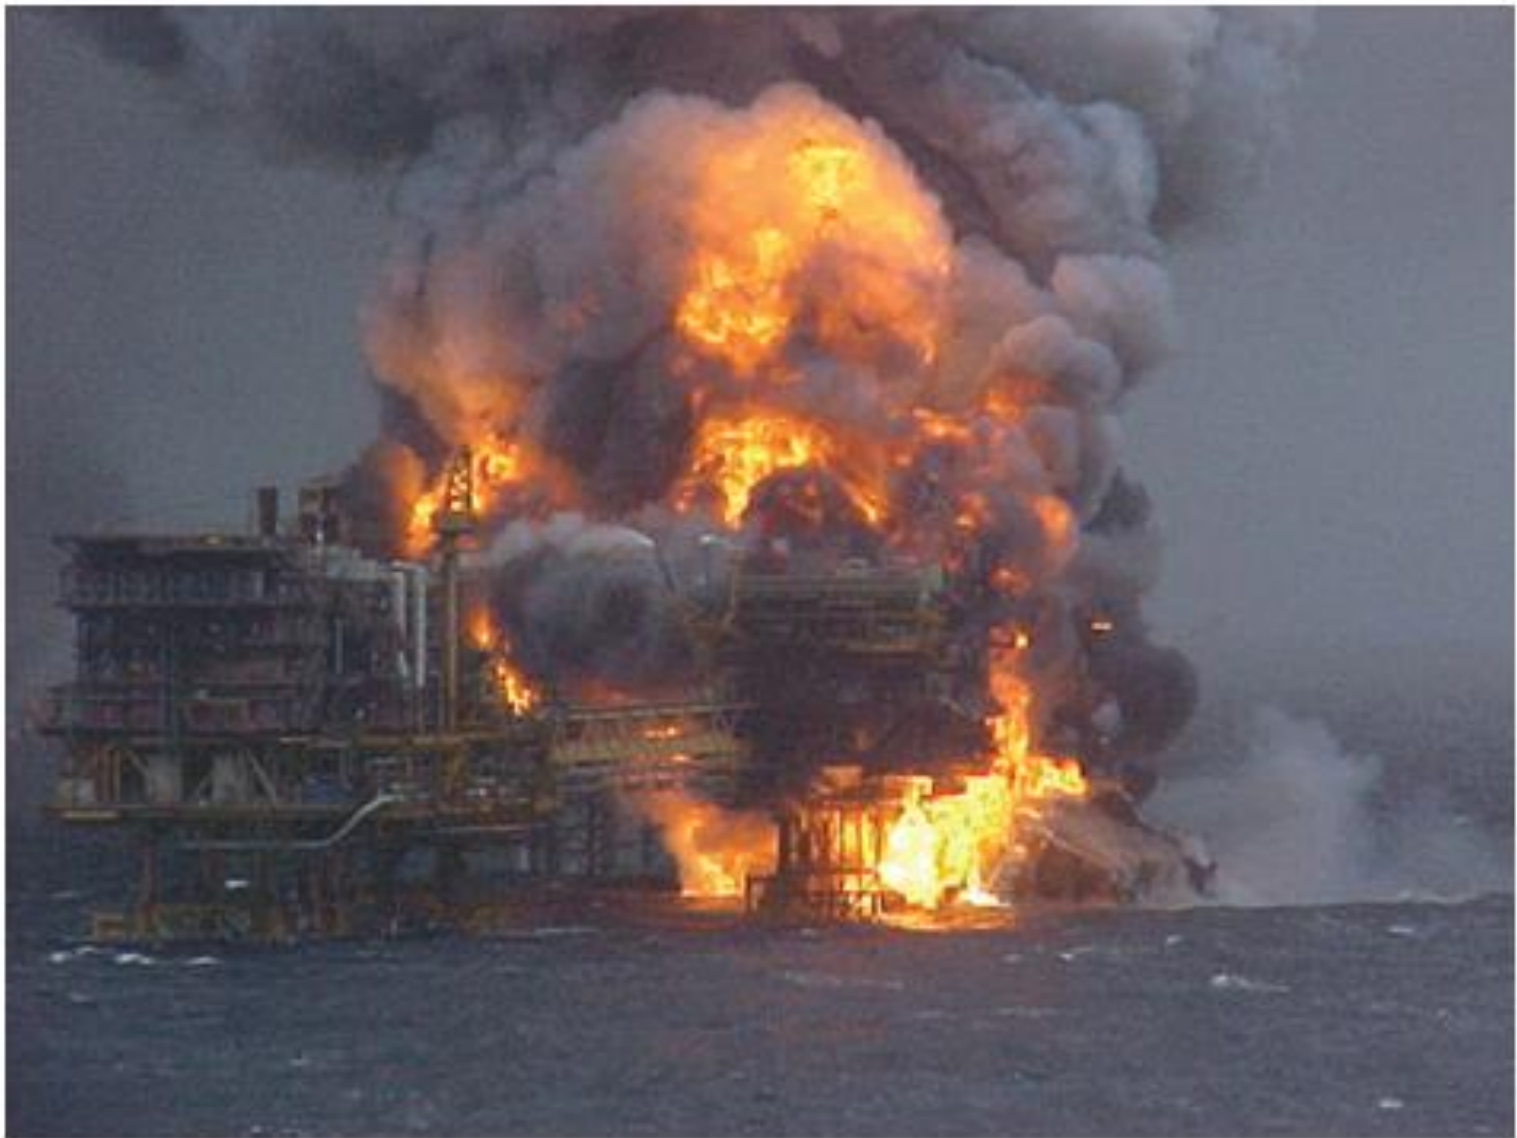
Figure 2. The smoke reached hundreds of feet above Piper Alpha, preventing rescue helicopters from approaching. Source: Technologism.net.

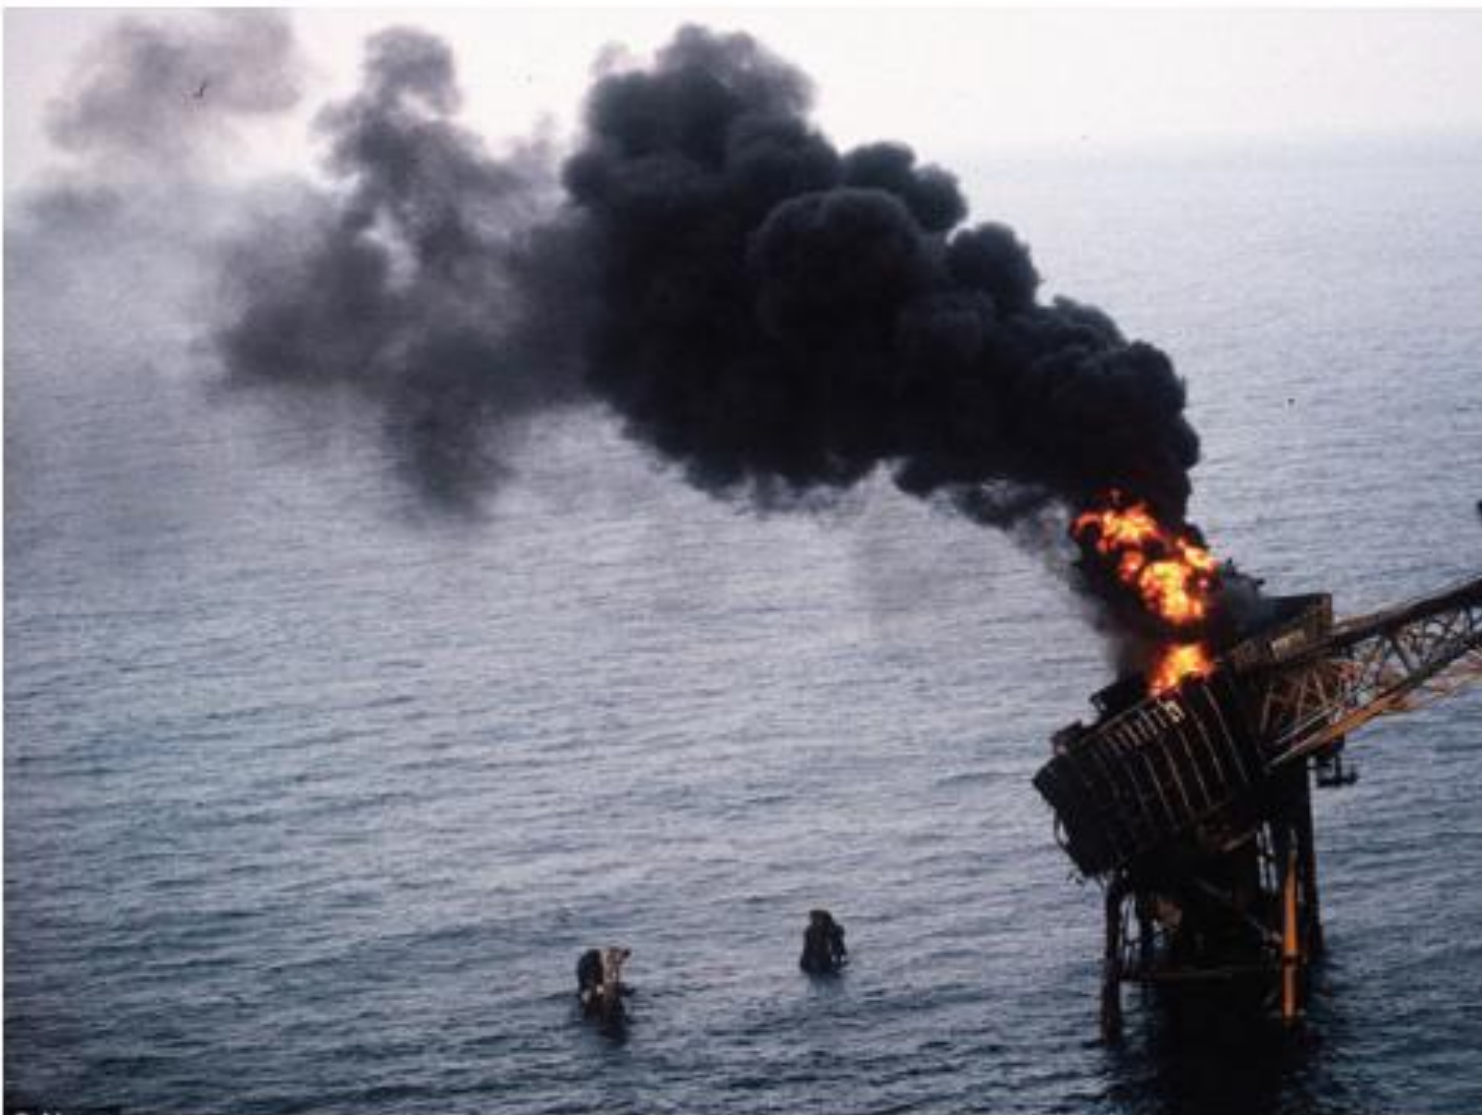
The entire deck was destroyed. By the morning of 7th July only the oil wells module remained standing.

Figure 3. The remaining oil wells module continued to burn for weeks until famed firefighter, Red Adair, and his team extinguished the remains. Source: BBC.

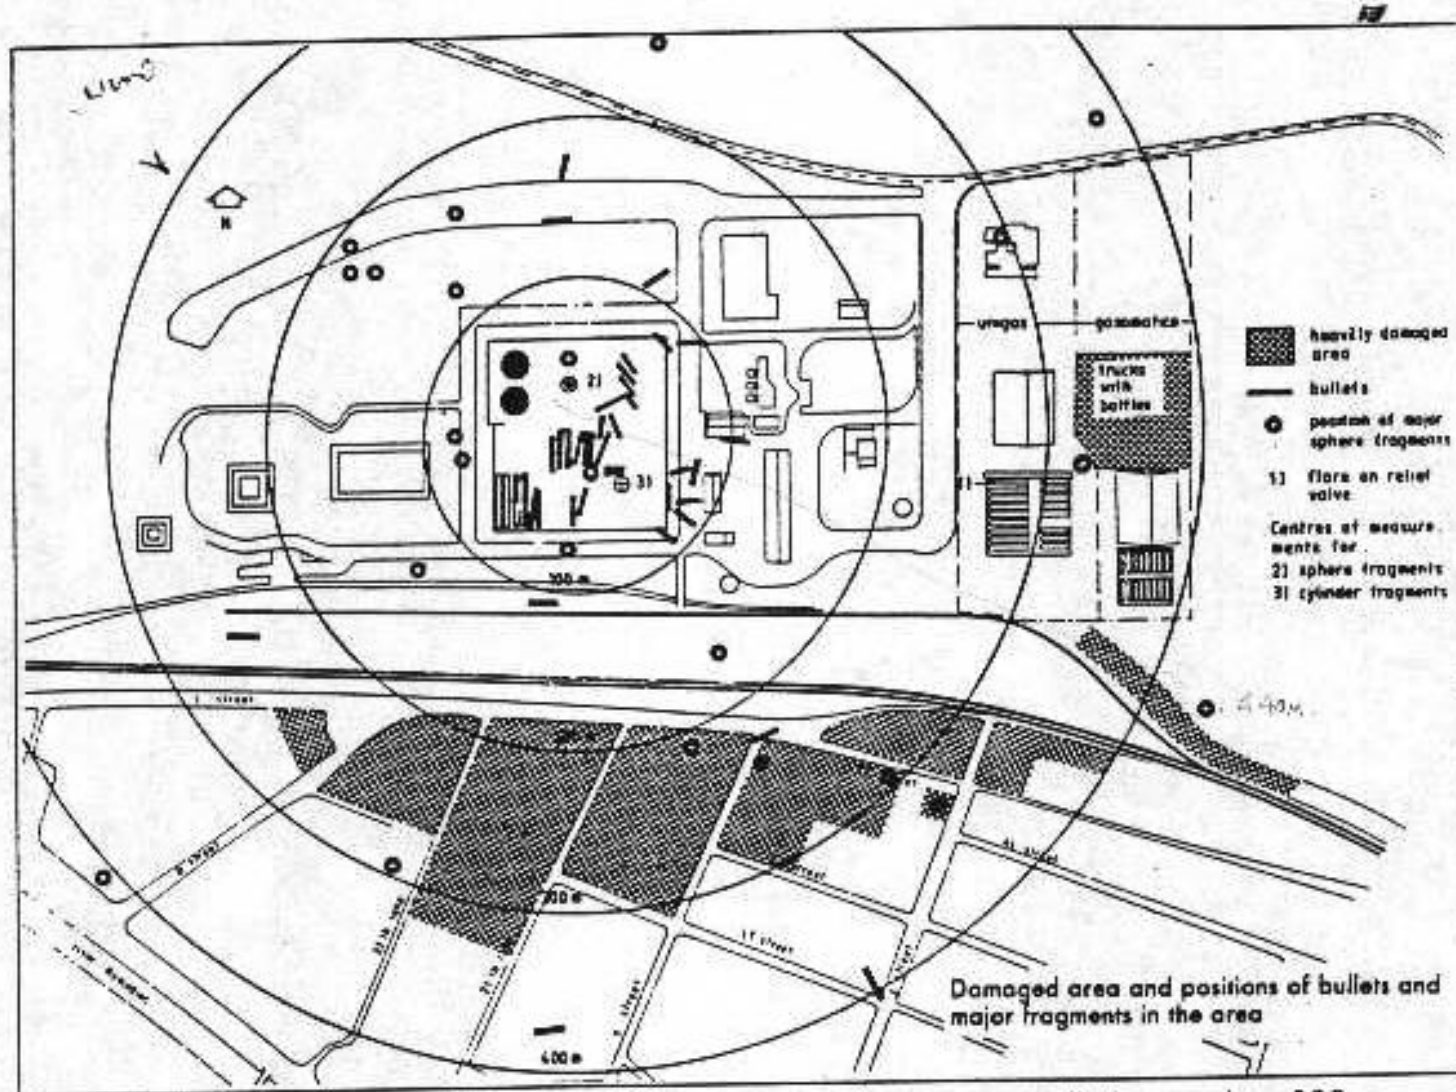
Plot Plan - After

Sketch of the damaged area. Some major sphere fragments were propelled more than 800 m. Note the damage to trucks with gas-filled bottles at the neighboring Gasomatica plant. Source: TNC

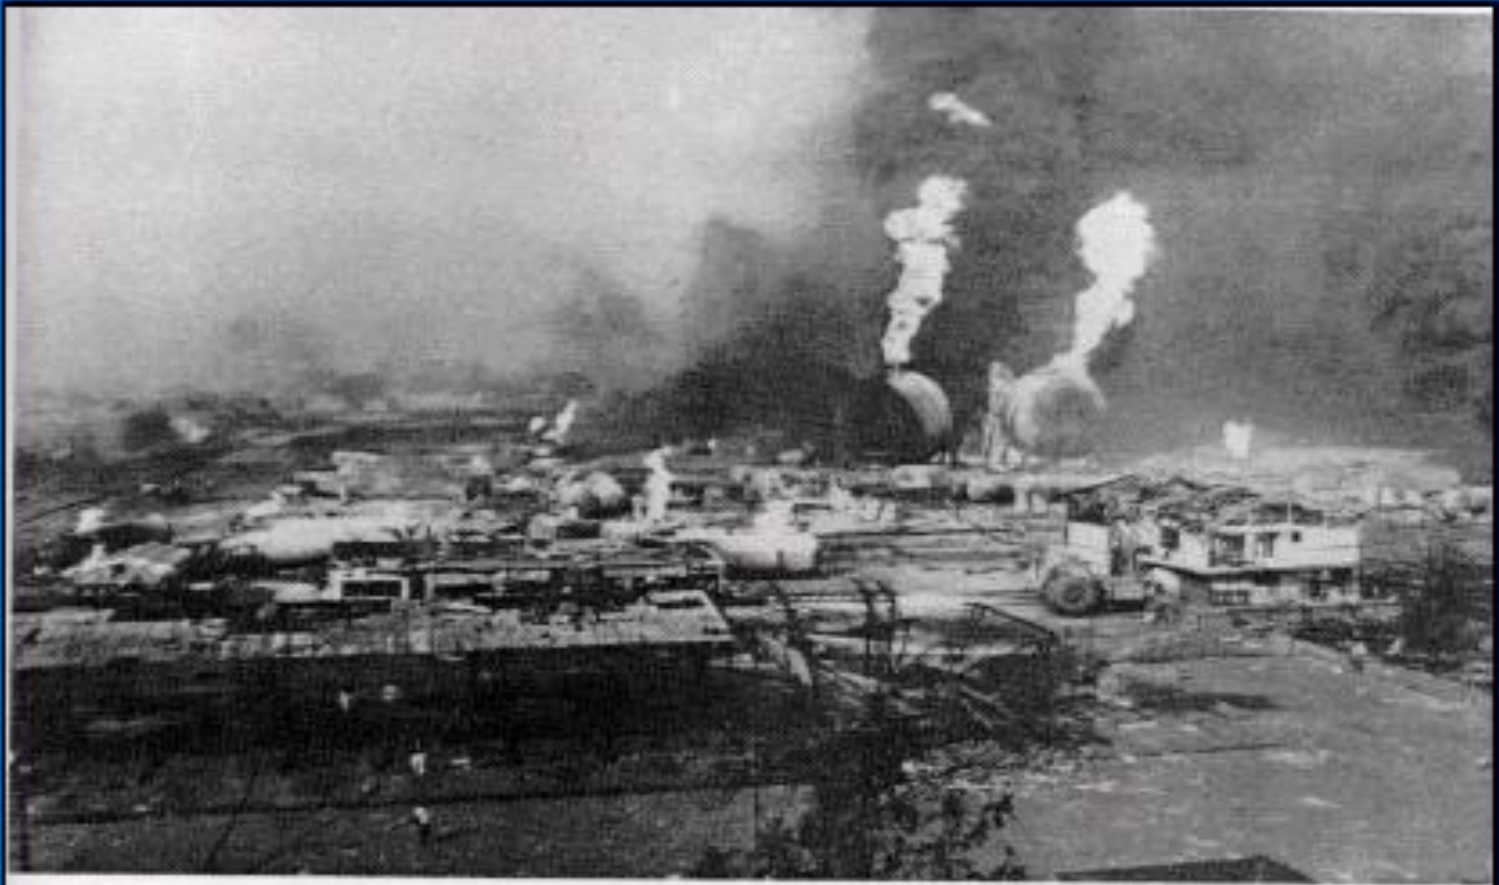
Burning Site

Photo 3. Burning site.

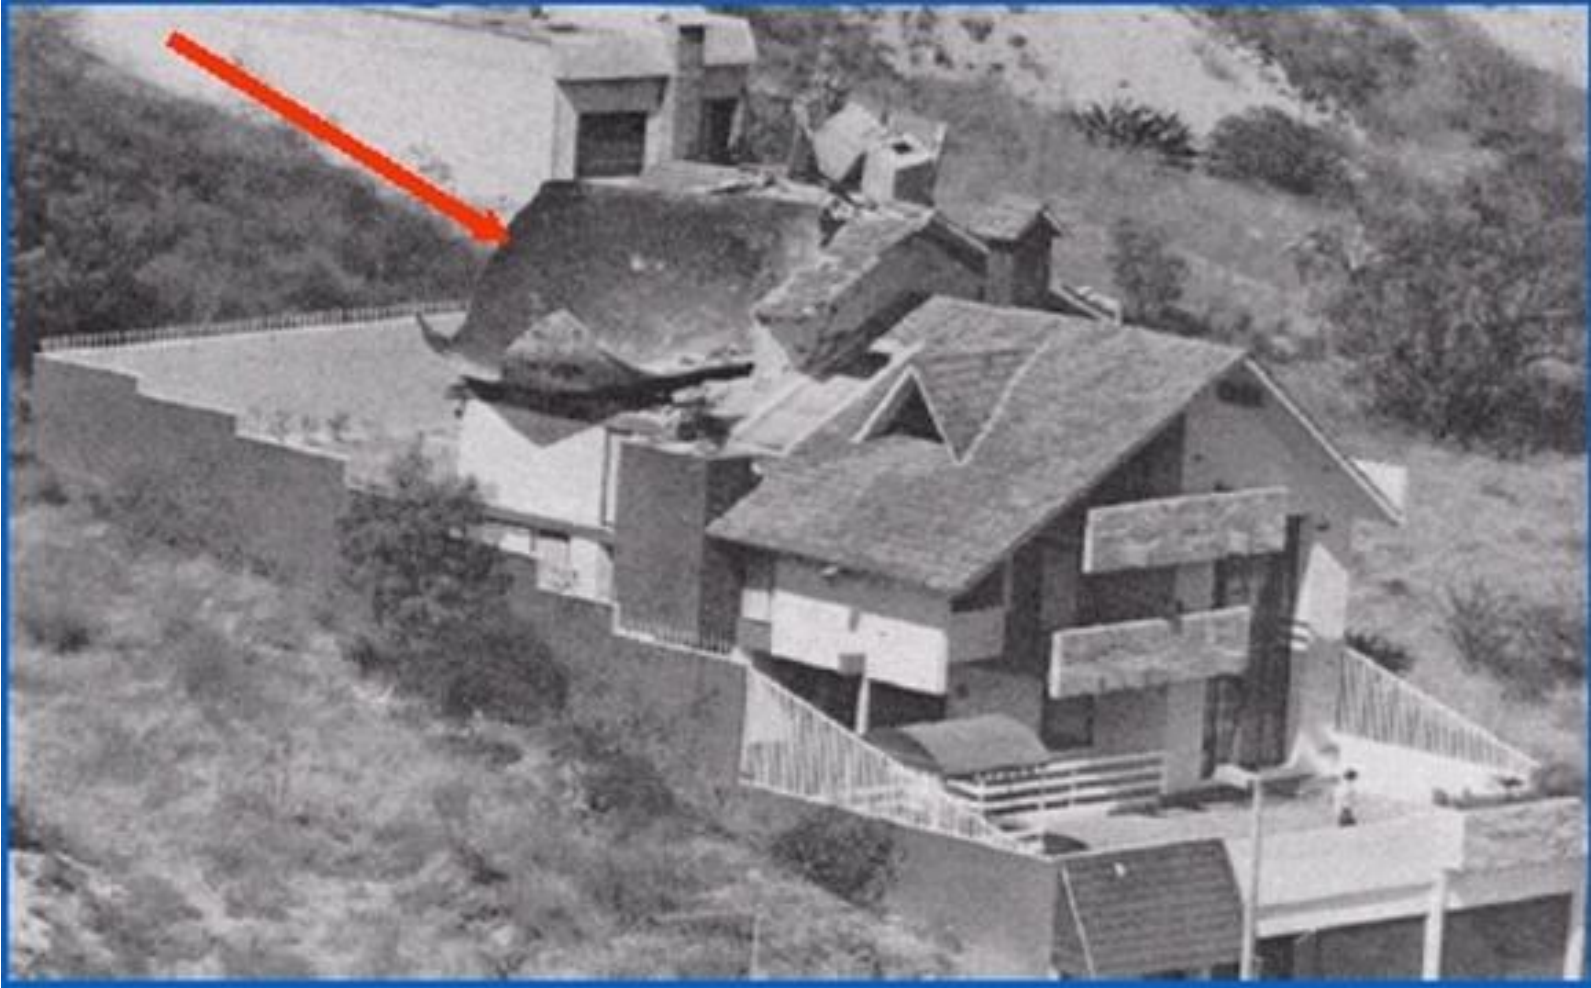
A Fragment in Copal Residential Area

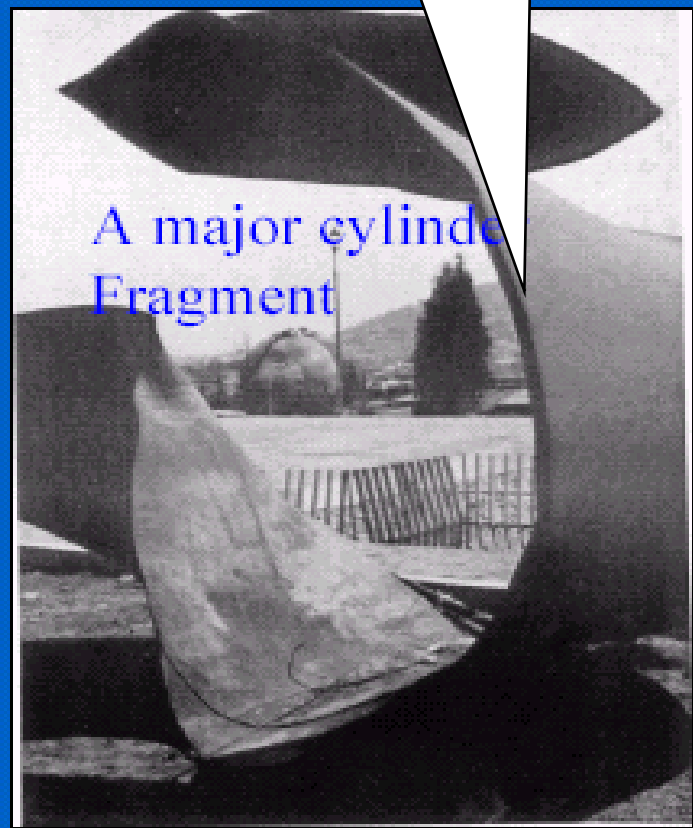
Major cylinder fragment

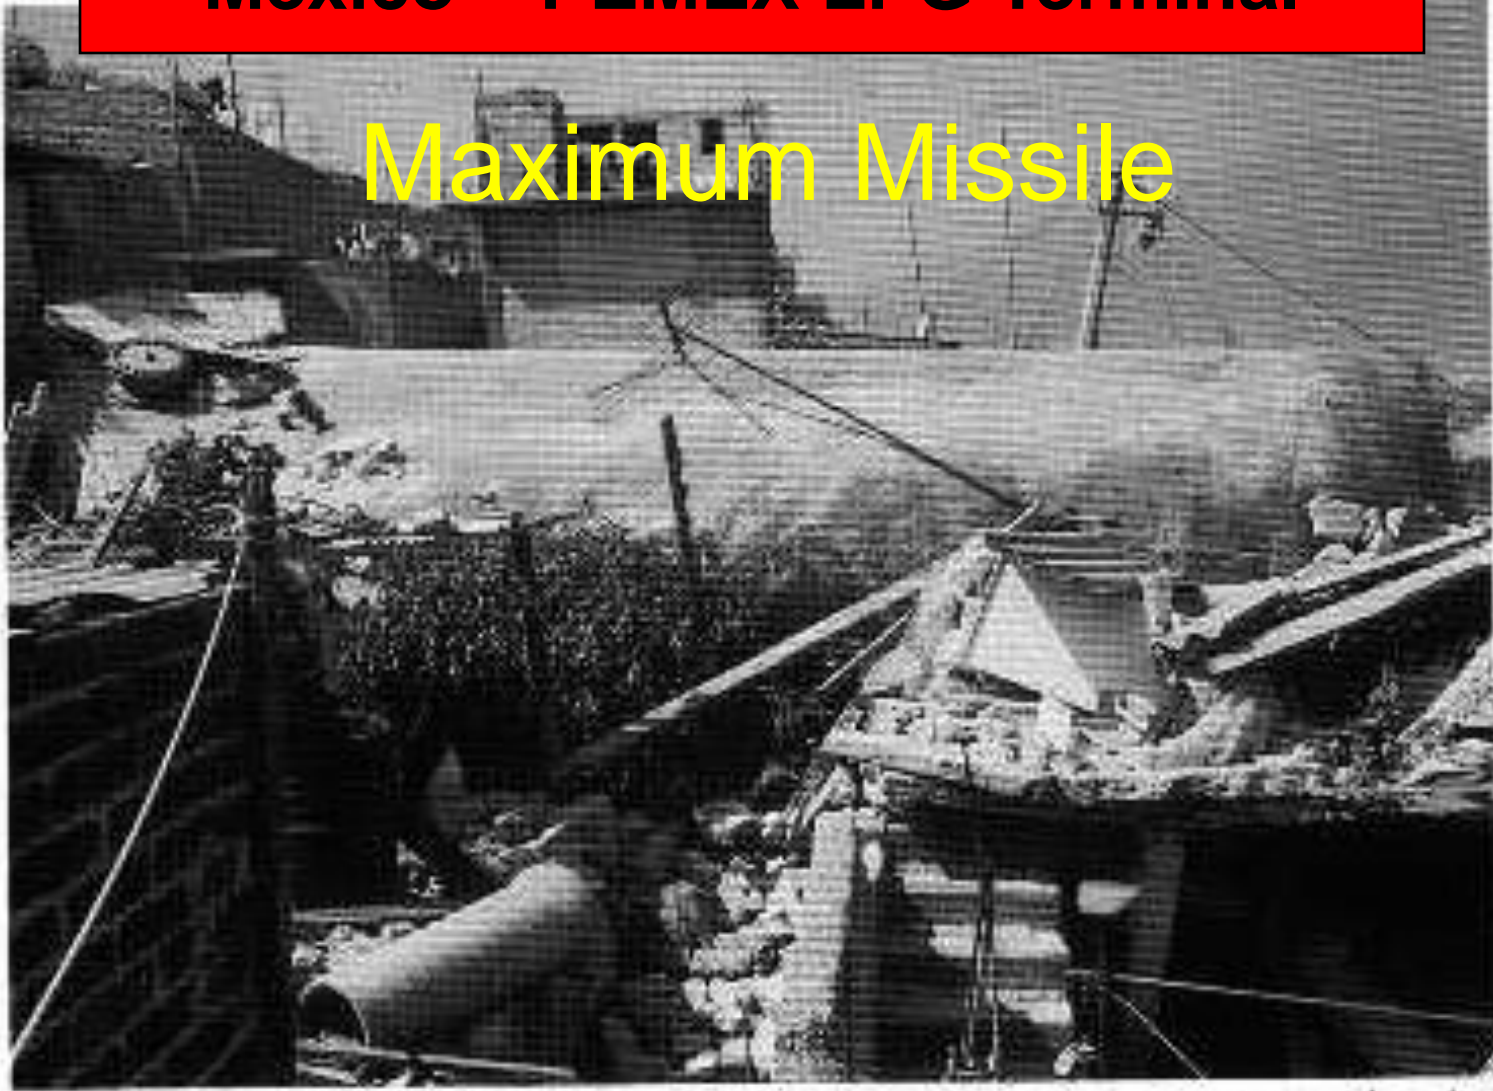
Maximum Missile

The cylindrical tank that flew furthest penetrated some 1,200 m into the housing area and crashed into a 2 storey house vacated one hour before.

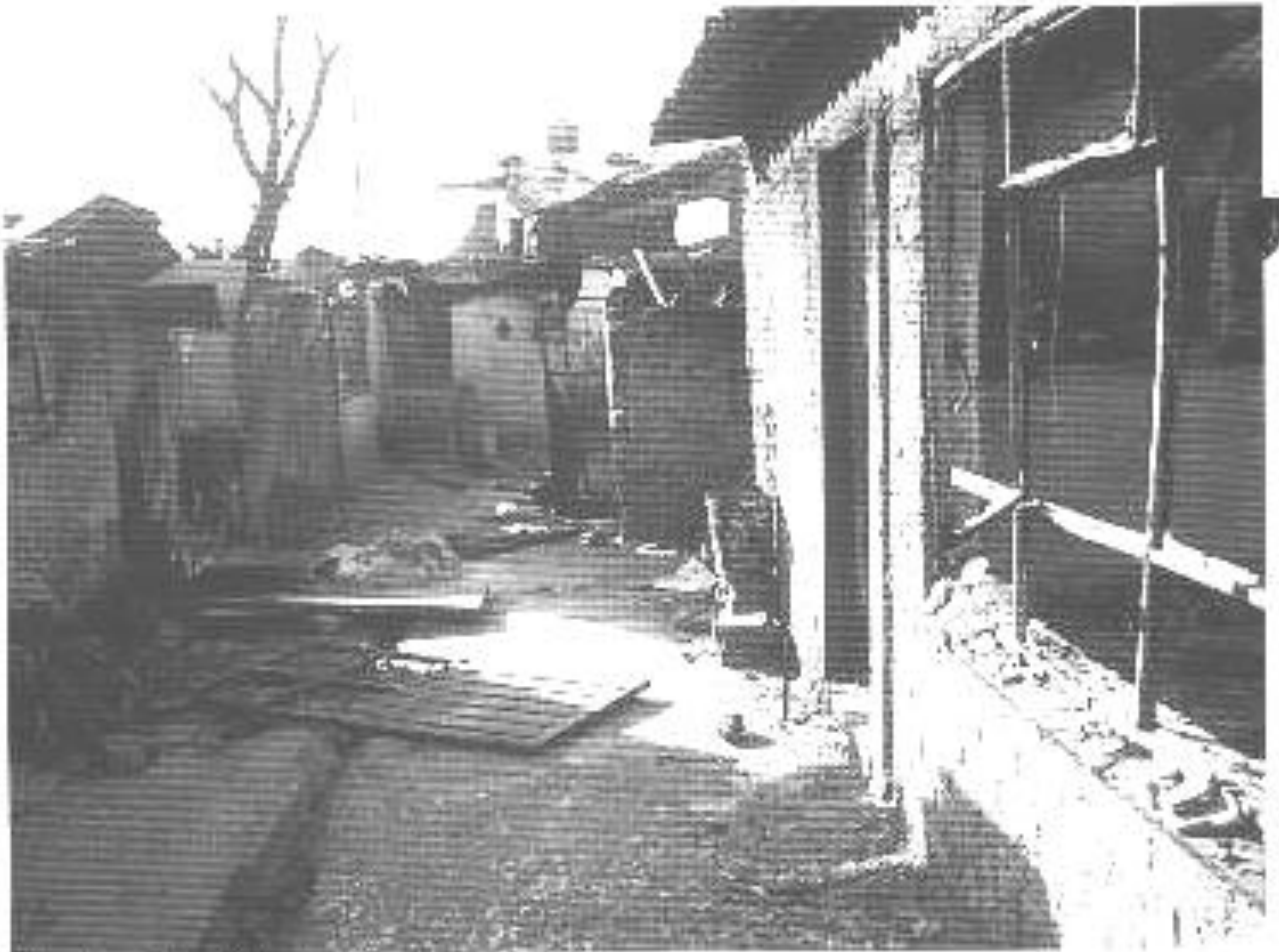
Nearby Houses

The desolation of the burnt-out houses recalled a war scene.
